Appendix A

Photo Logs

Facility Siting General Photolog

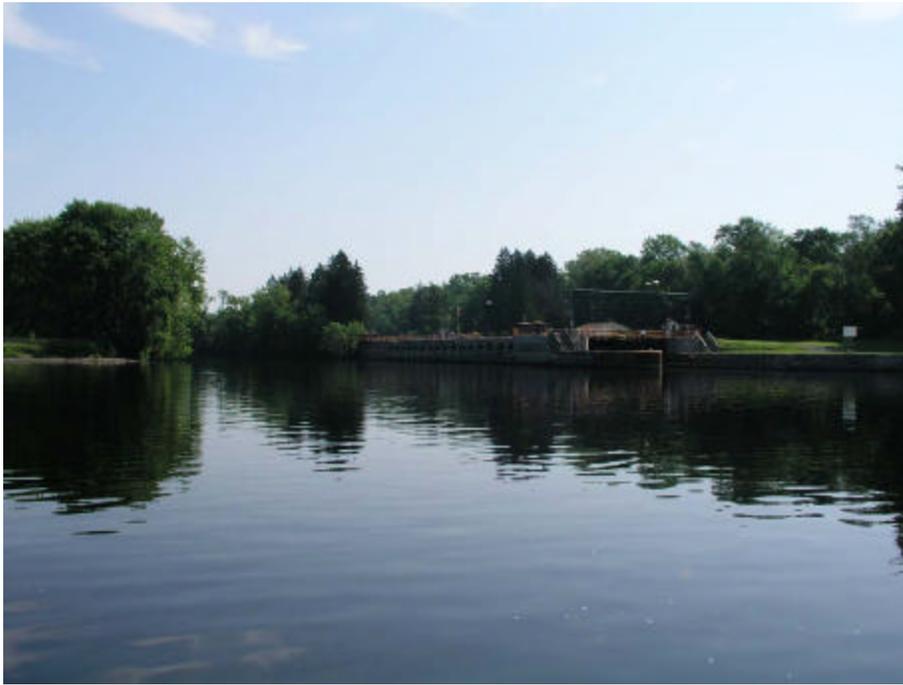
View to northeast of Lock 7 from Hudson River (07/31/03). Note: Lock 7 connects the Hudson River to the Champlain Canal.

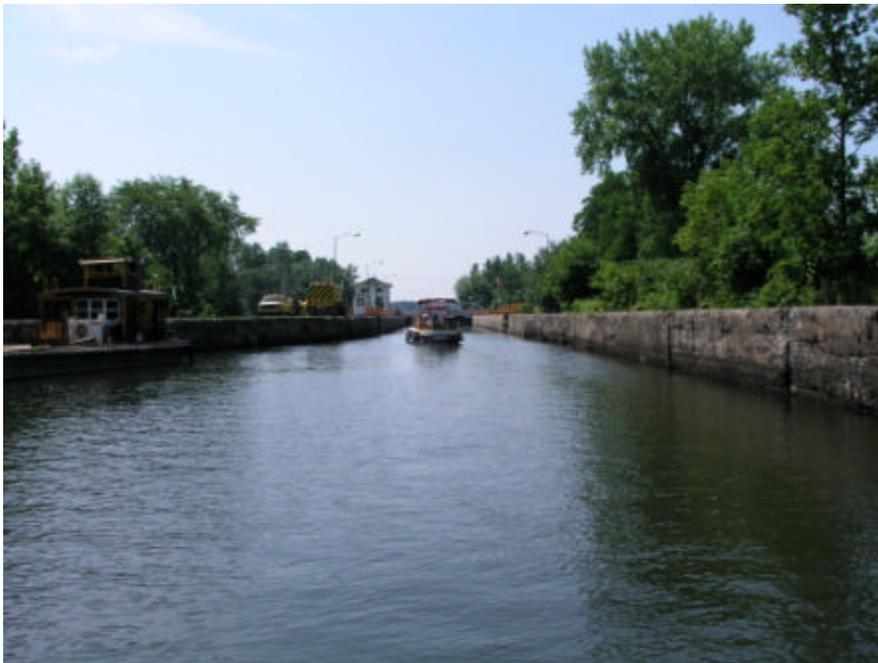
View to south of upstream entrance to Lock 6 (07/31/03). Note that the entrance is via a long and narrow channel paralleling the Hudson River.

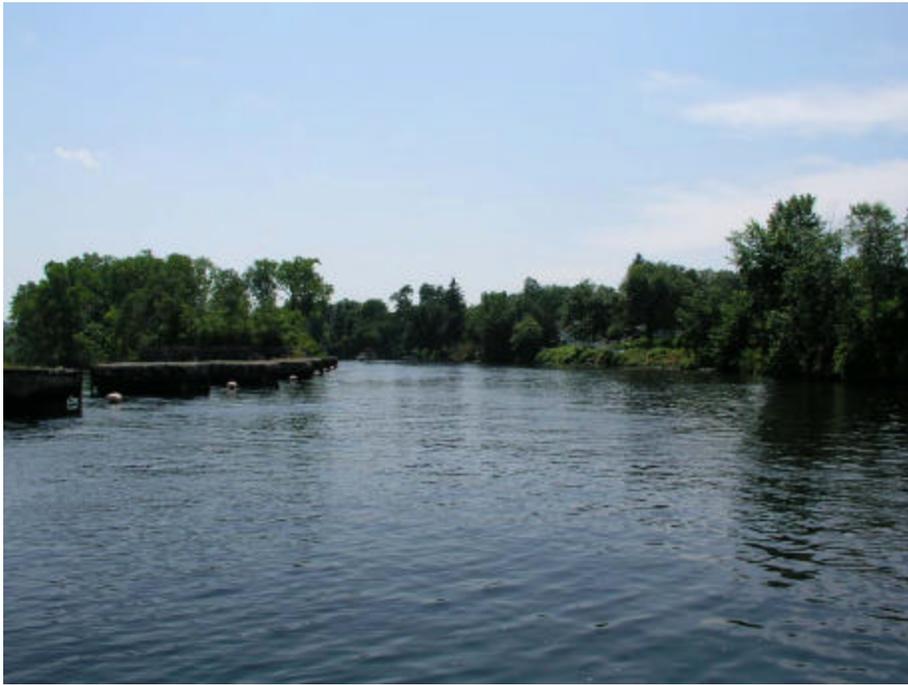
View to south of upstream entrance to Lock 5 (07/31/03).

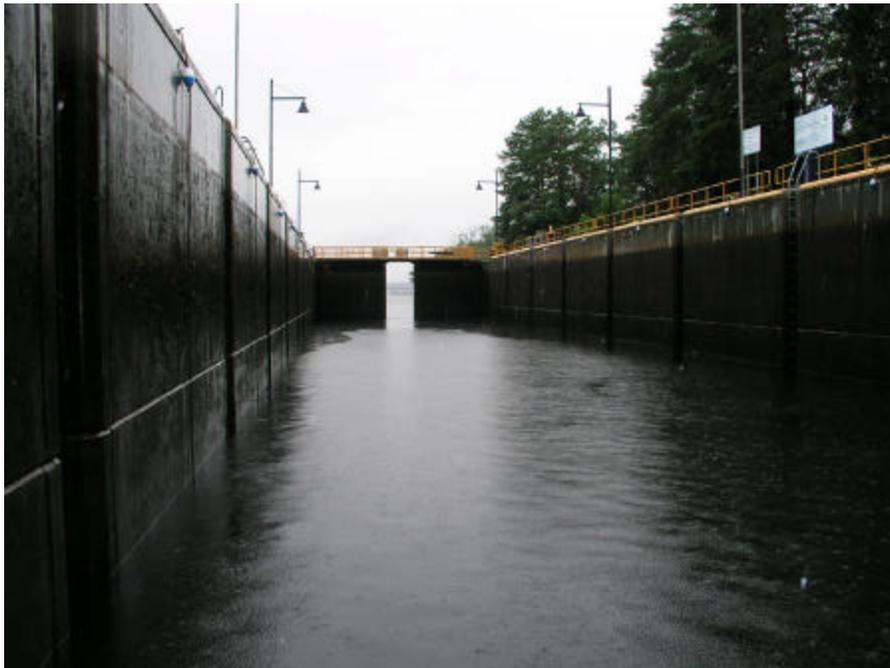
View to south of empty Lock 4 (08/1/03).

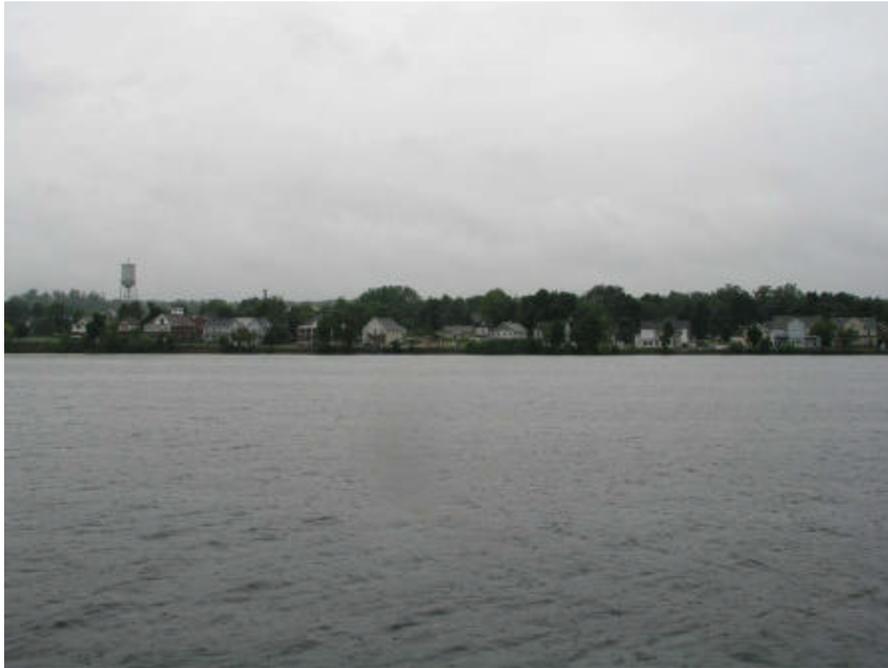
View to west of west bank of Hudson River opposite the Bruno/Brickyard/Alonzo site (08/01/03).

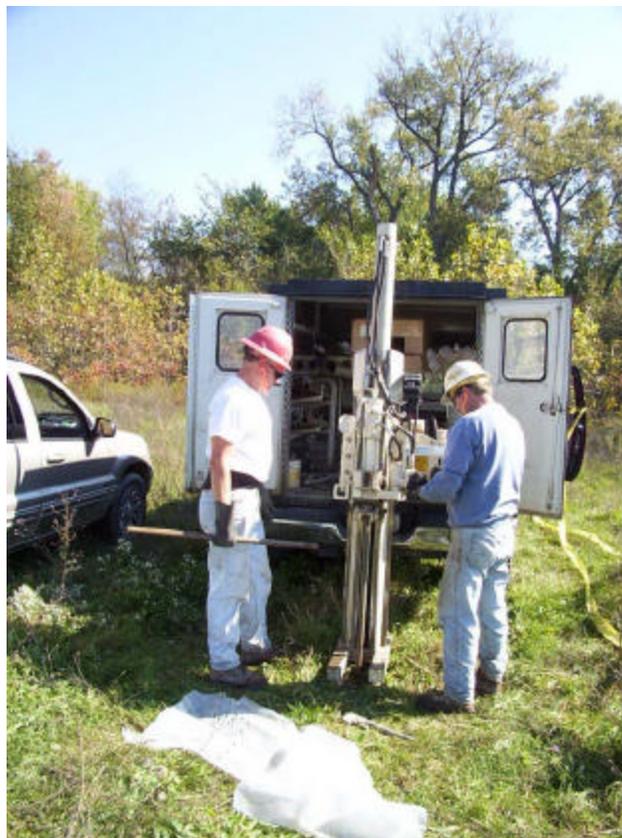
Typical Geoprobe activities (10/08/03).

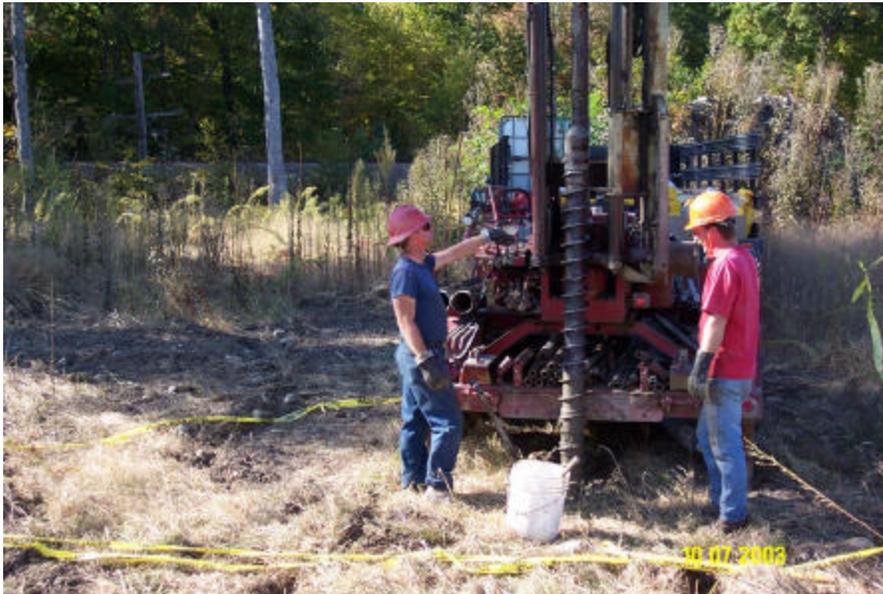
Typical drilling of Geotechnical boreholes (10/07/03).

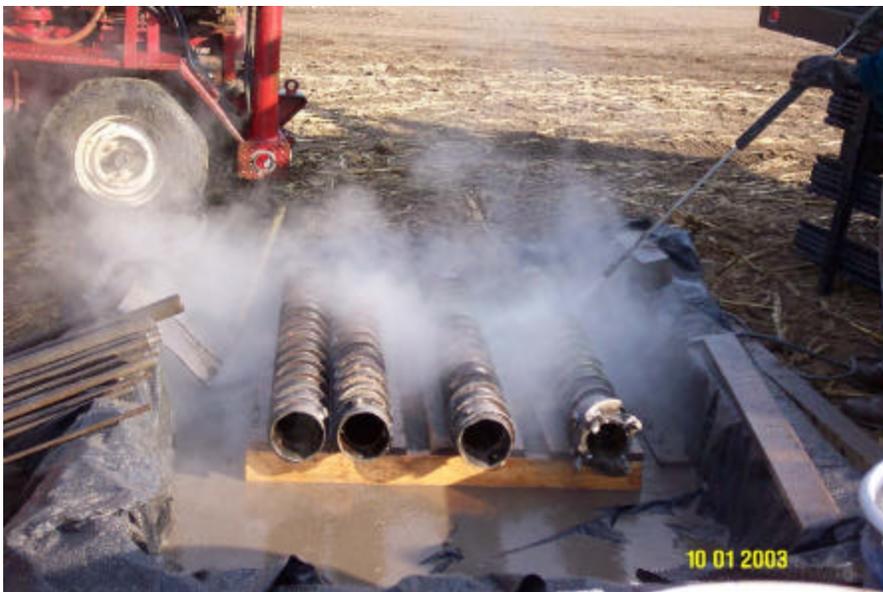
Typical Steam cleaning of augers (10/01/03).

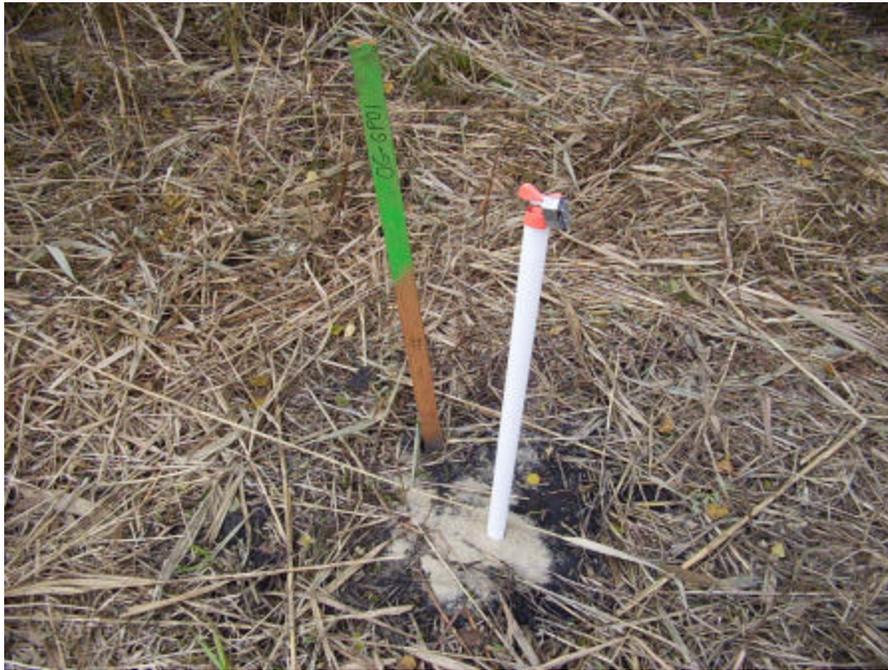
Typical completed temporary well (10/16/03).

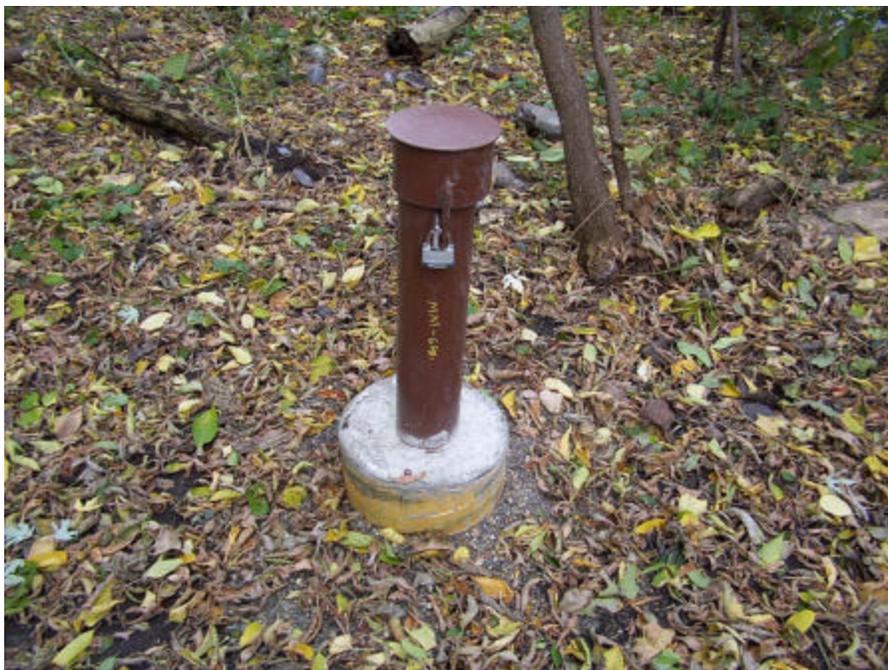
Typical completed temporary well at State of NY/First Rensselaer/Marine Management site (10/16/03).

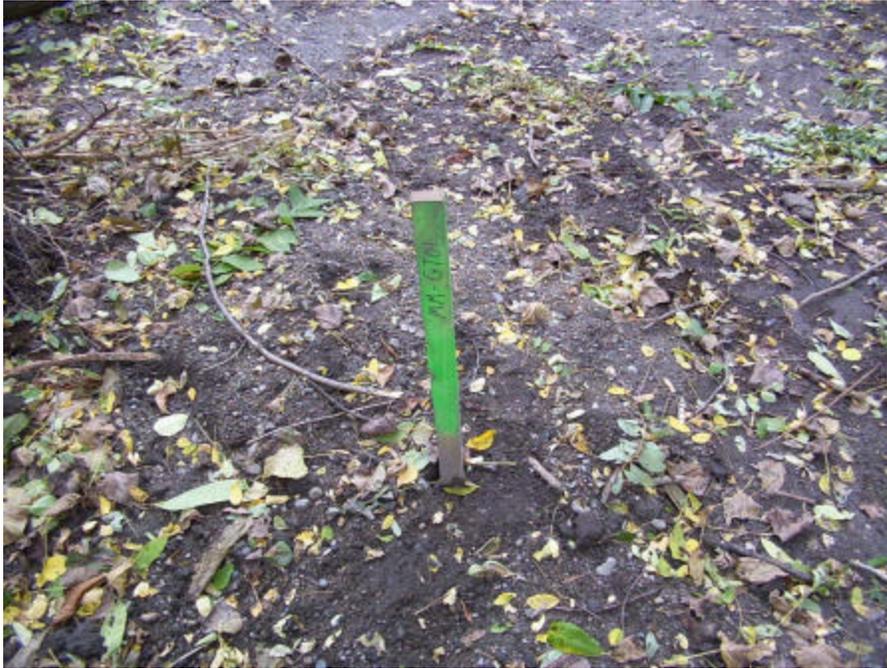
Typical completed (backfilled) soil boring (10/16/03).

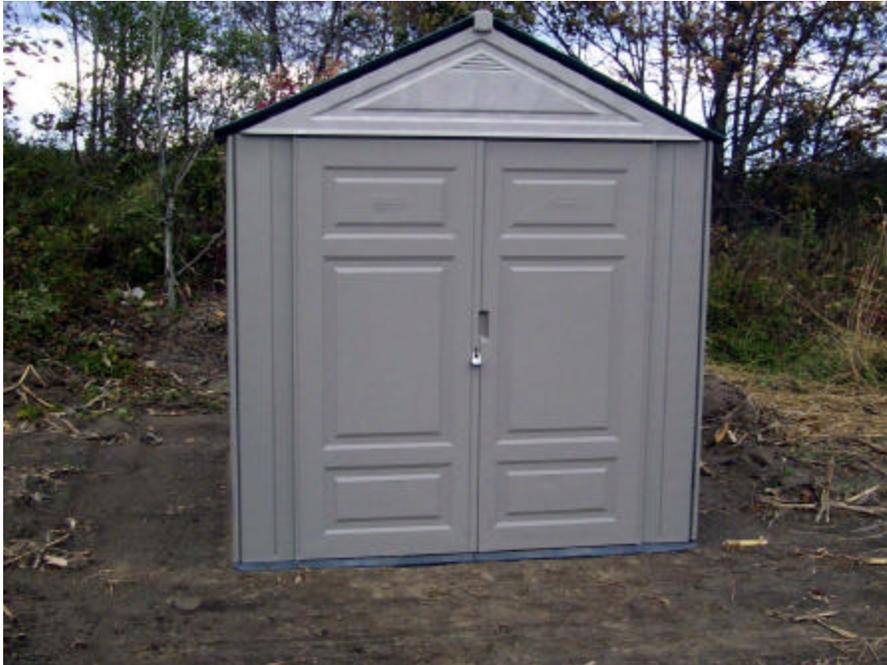
Typical drum storage shed (10/16/03).

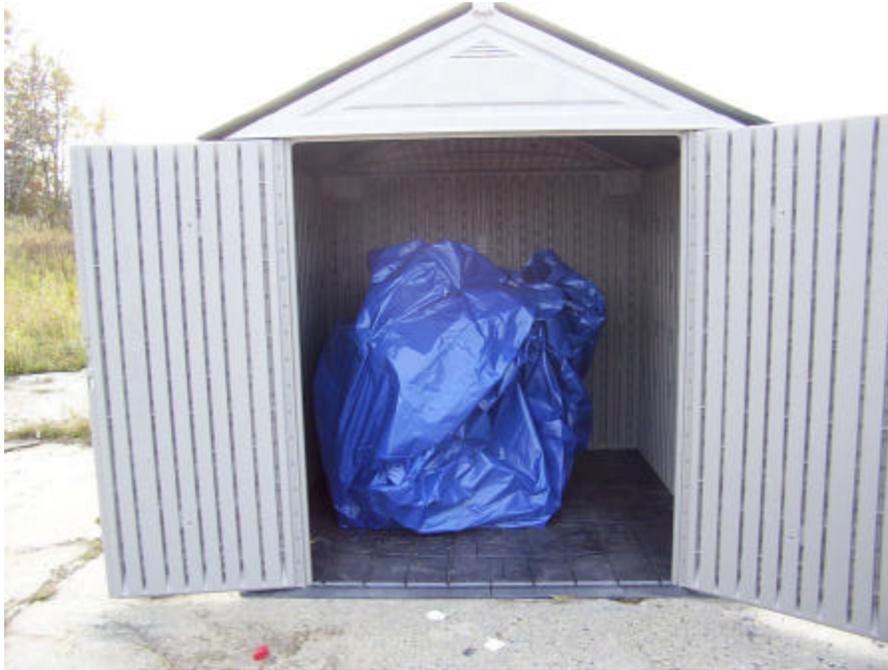
Inside of typical drum storage shed (10/15/03).

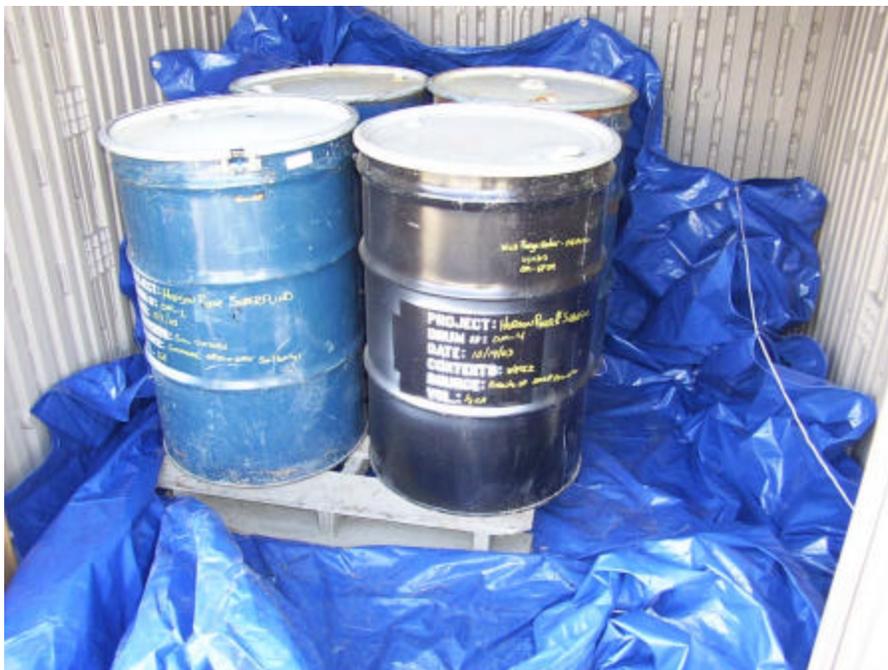
Typical arrangement of drums inside the storage sheds (10/16/03).

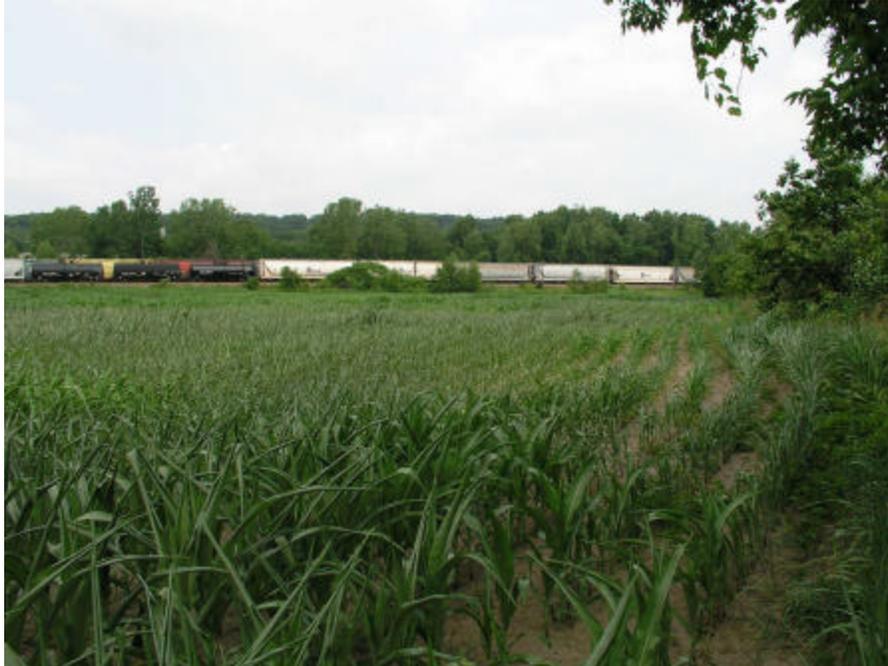
View to west of center of property – cornfield (07/08/03).

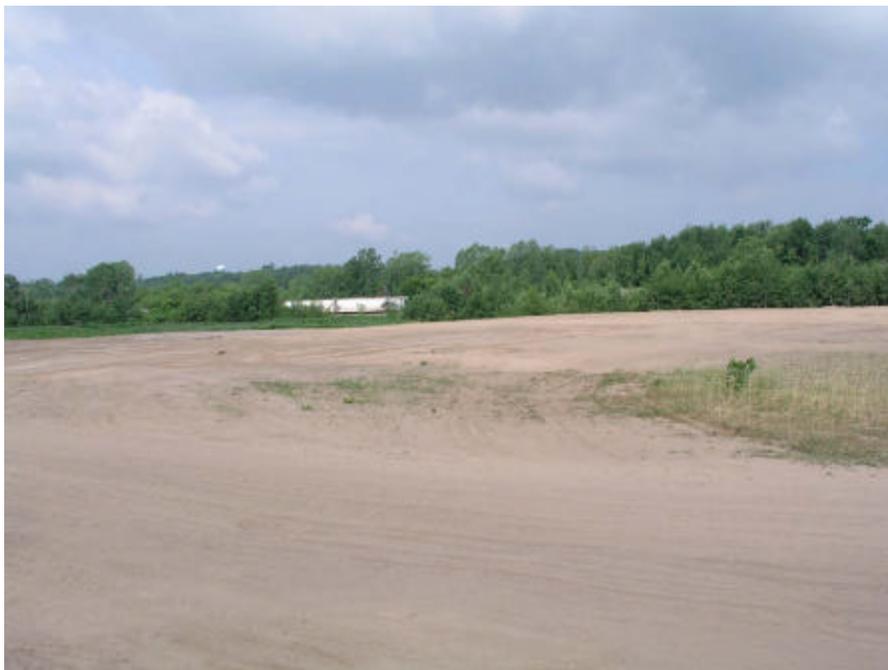
View to north of fill area in center of site (07/08/03).

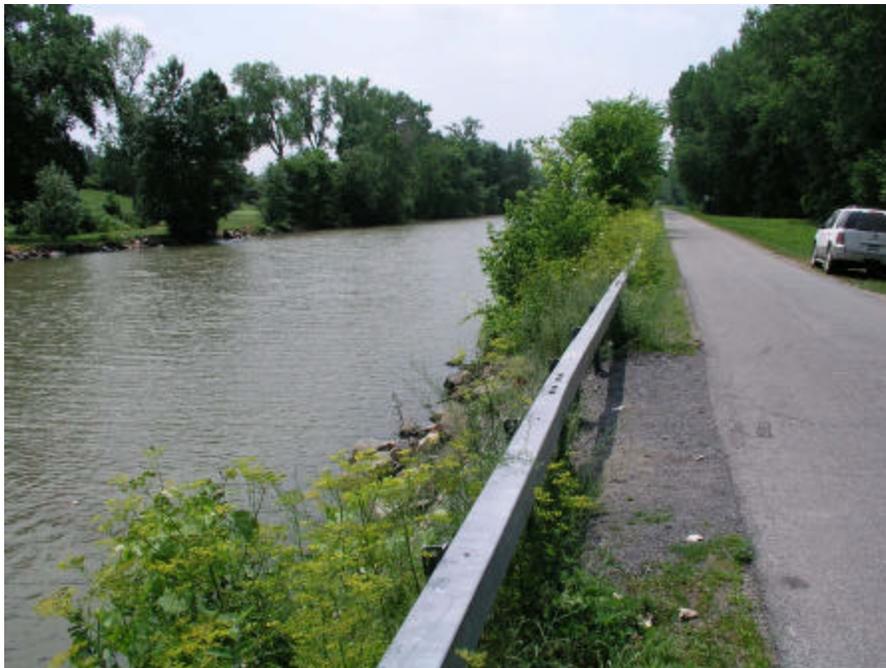
View to southwest of Champlain Canal and adjacent Canal Road along southeast side of parcel (07/08/03).

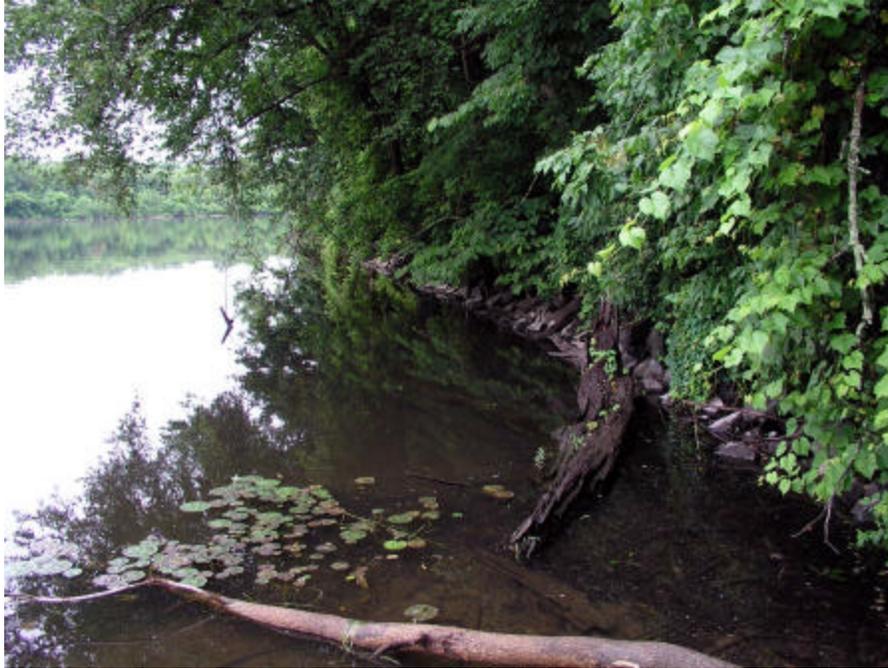
View downstream of Hudson River shoreline (07/11/03).

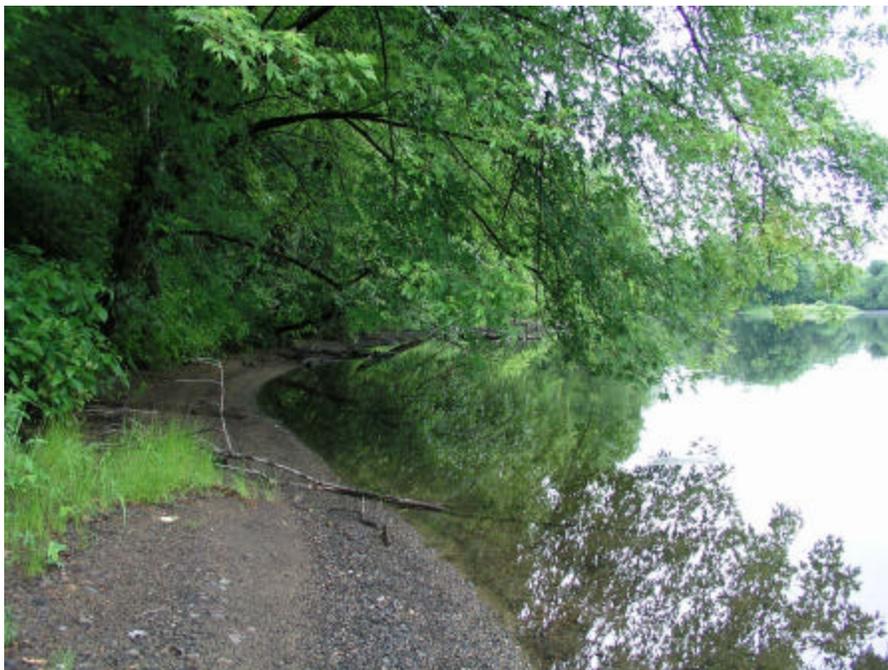
View to north of Hudson River shoreline (07/11/03).

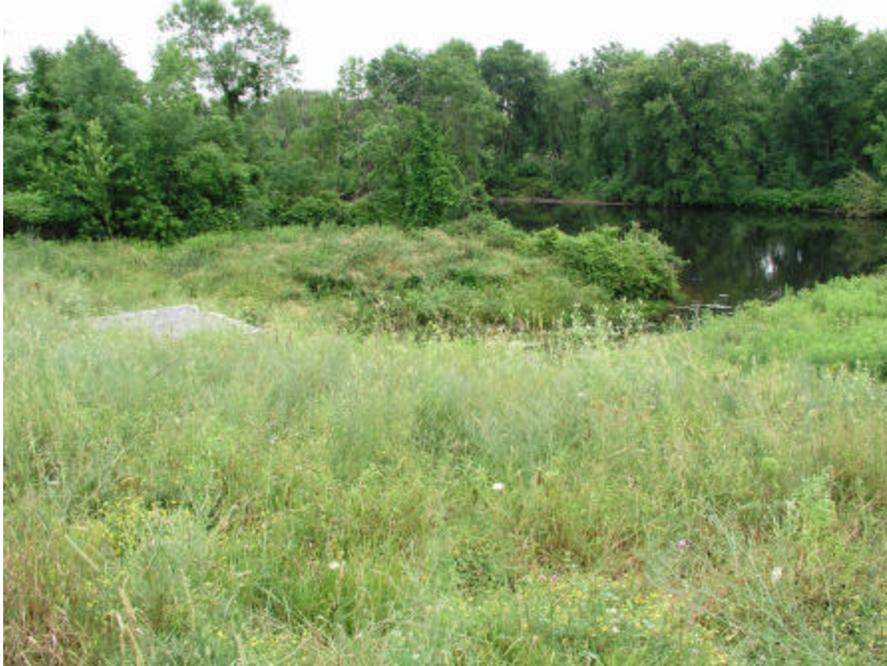
View to northeast of former pumphouse channel (07/11/03).

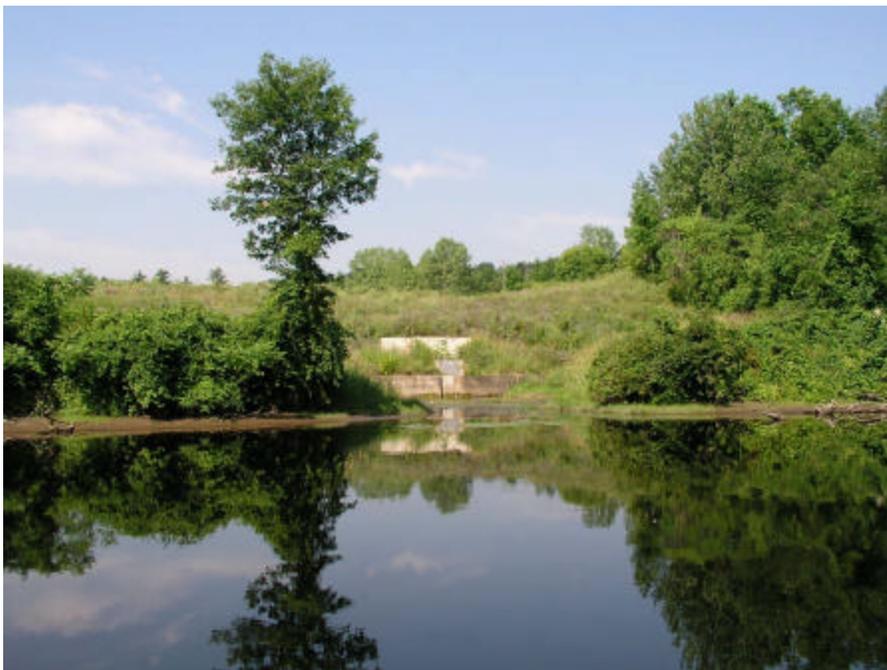
**View to west of Old Moreau (near former paper recycling facility)
from Hudson River (07/31/03).**

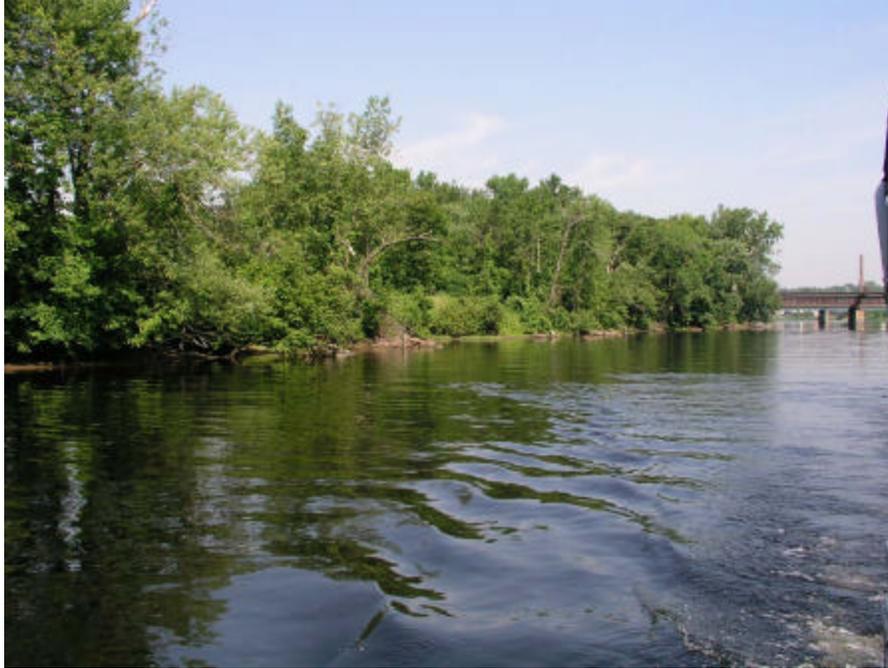
View to northwest of Old Moreau from Hudson River (07/31/03).

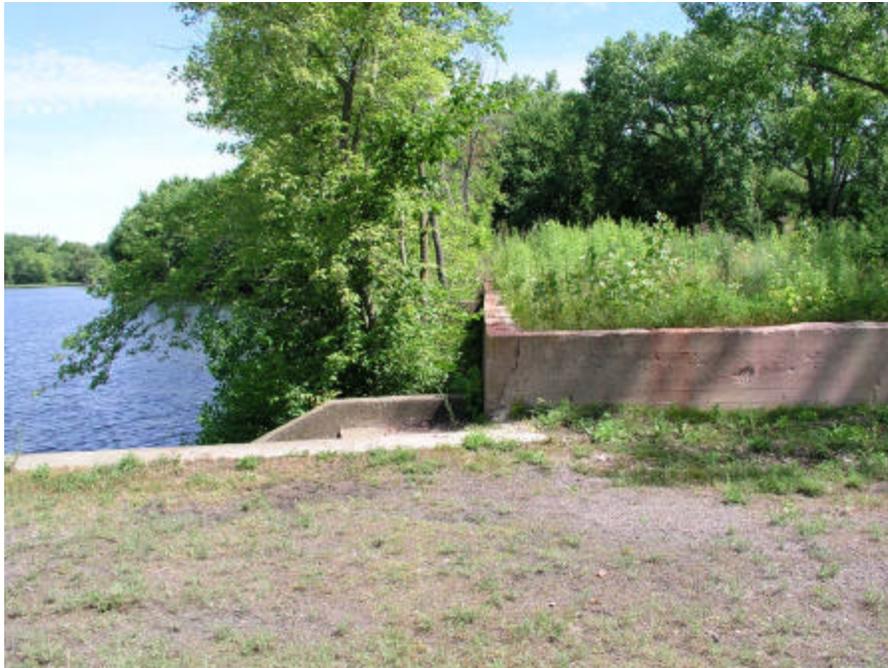
View upstream of north end of dock (07/10/03).

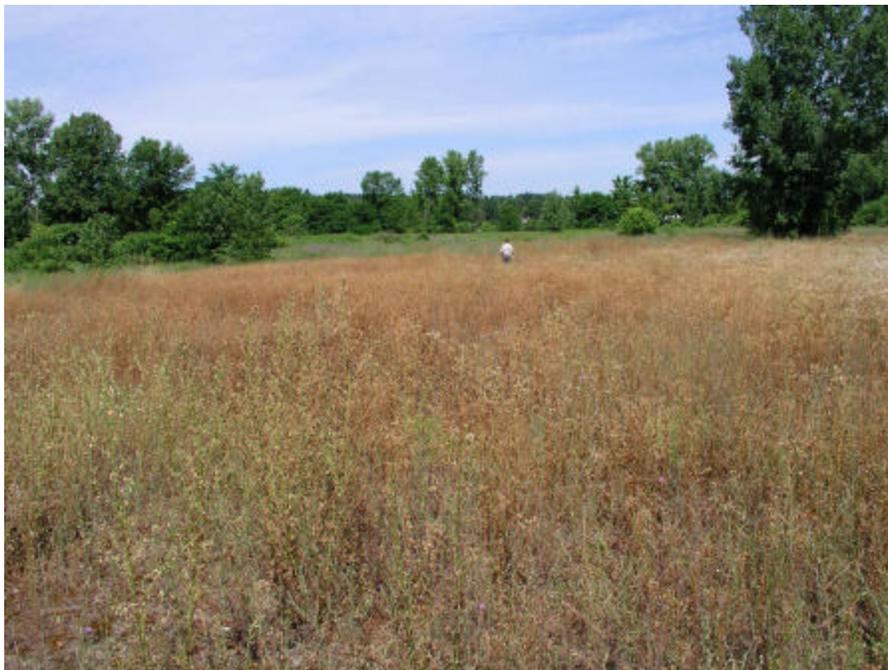
View to northwest of former land farm area (07/10/03).

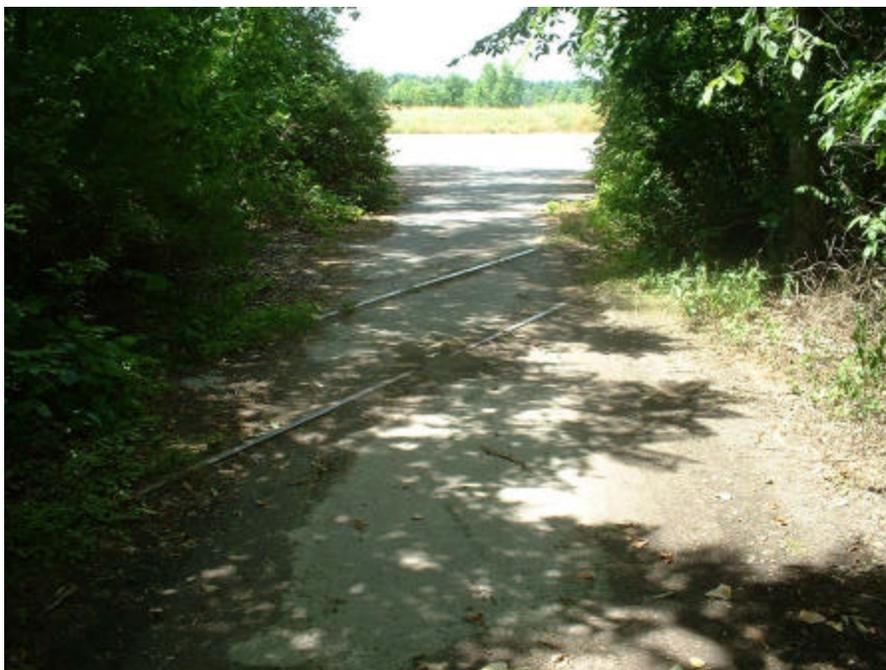
View to southeast of northernmost railroad spur to the southwest of the former power canal (07/10/03).

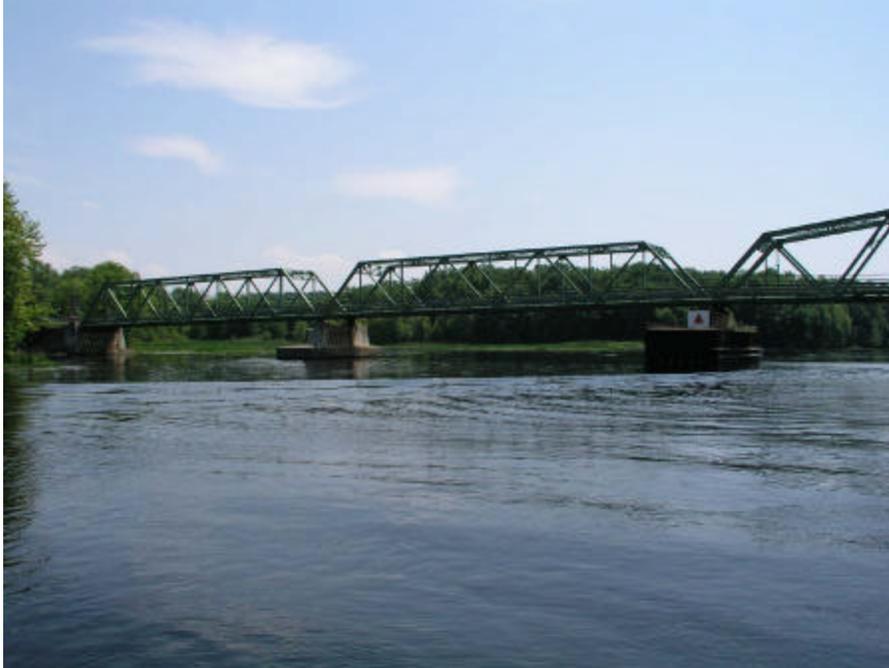
View to southeast of the Georgia Pacific site from Hudson River, upstream of the Route 4 bridge (07/31/03).

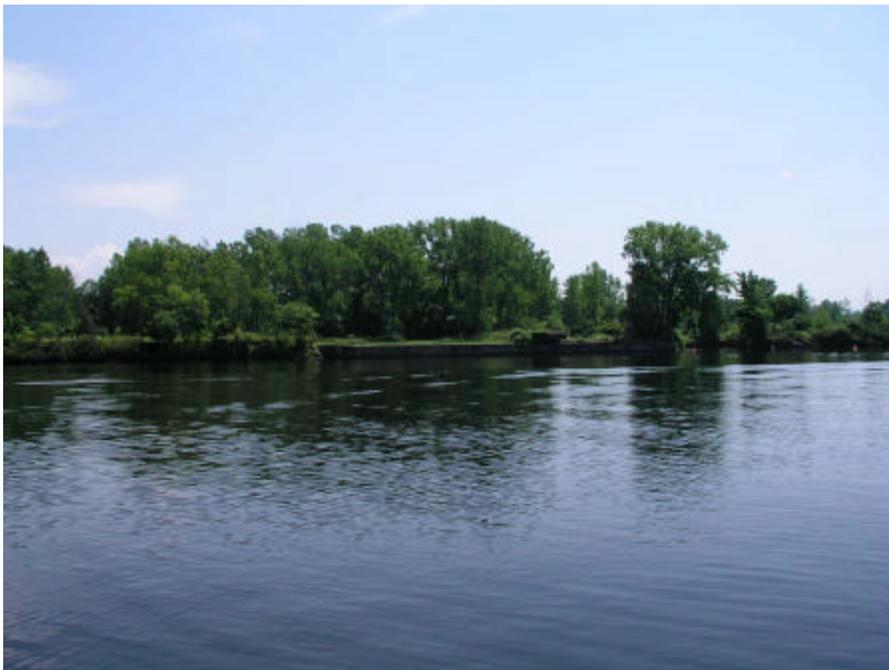
View to southeast of Georgia Pacific site downstream of the Route 4 bridge (07/31/03).

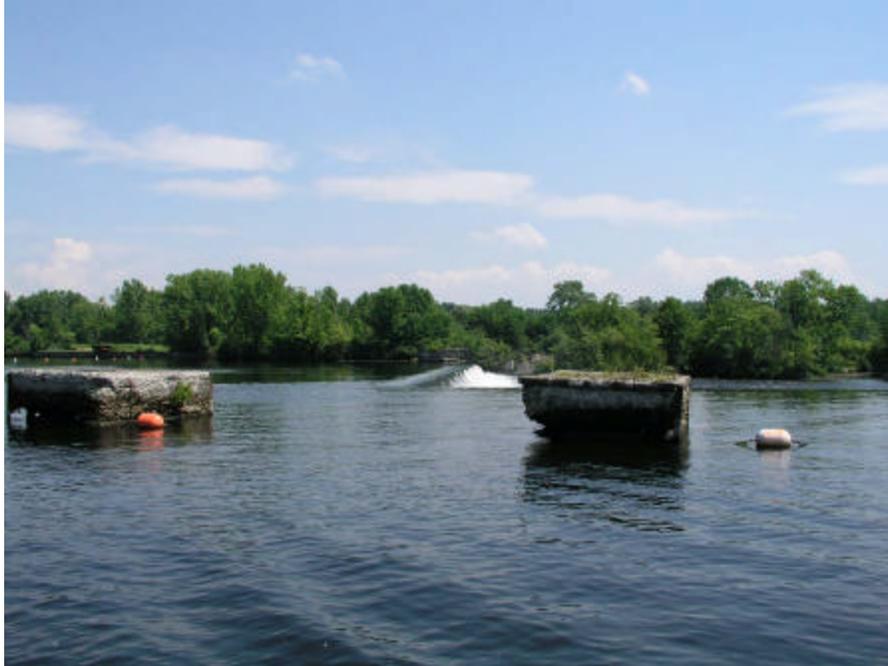
View to east of Northumberland Dam and Georgia Pacific site shoreline (07/31/03).

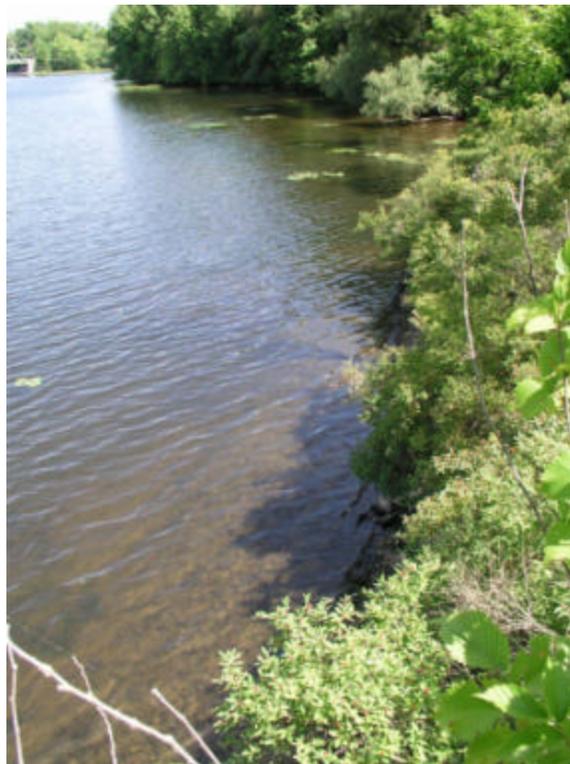
View to north shoreline from bulkhead 07/10/03.

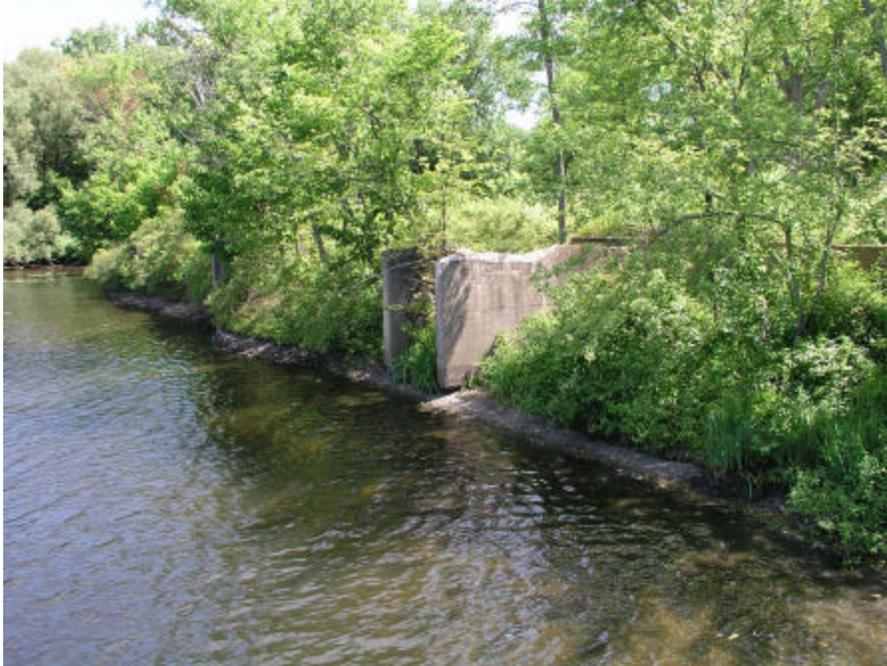
View to north of concrete structure along shoreline, north of bulkhead (07/10/03).

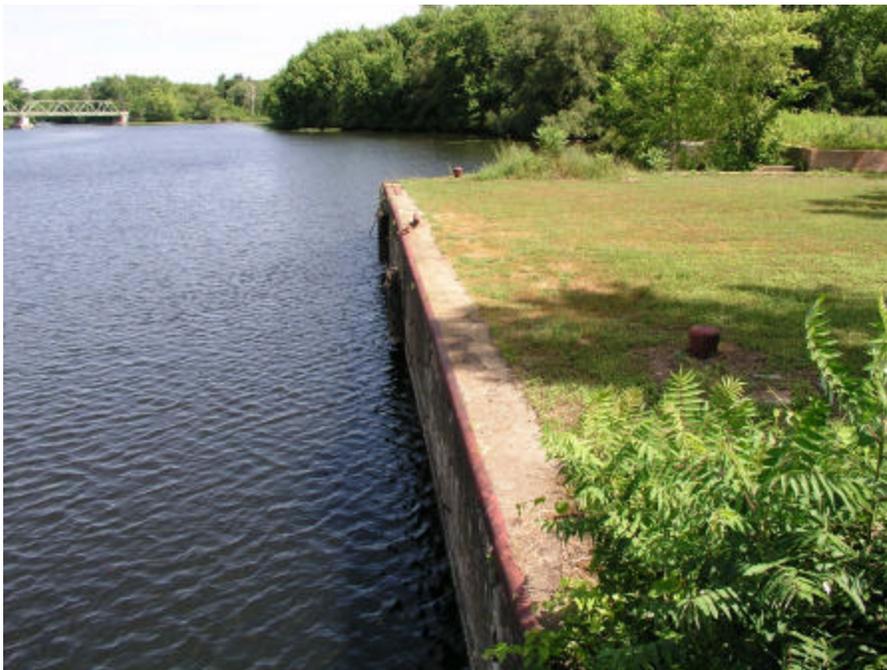
View to north from bulkhead (07/10/03).

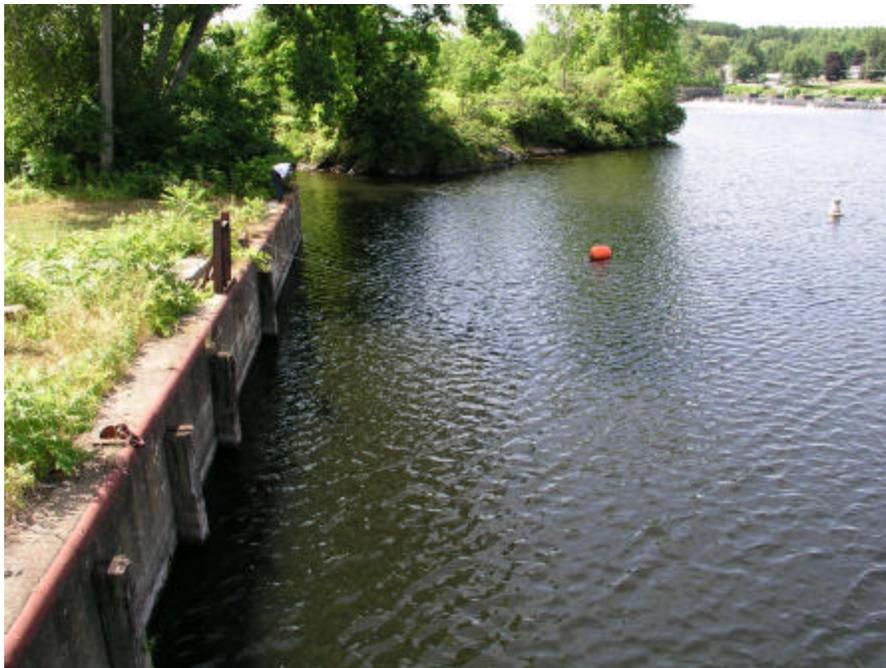
View to south from bulkhead. Note entrance to former power generating canal just north of bulkhead (07/10/03).

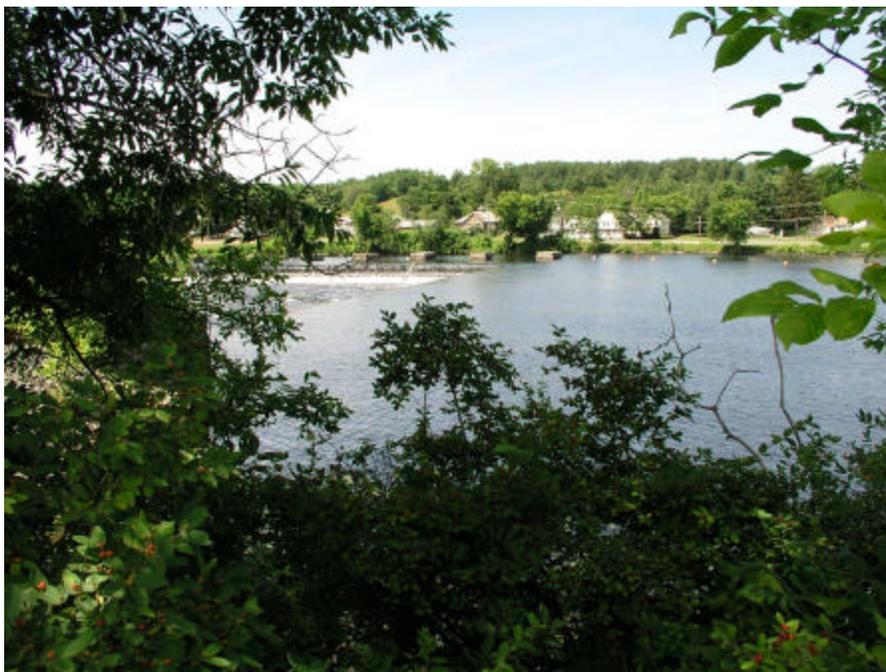
View to west of Northumberland Dam from Georgia Pacific site (07/10/03).

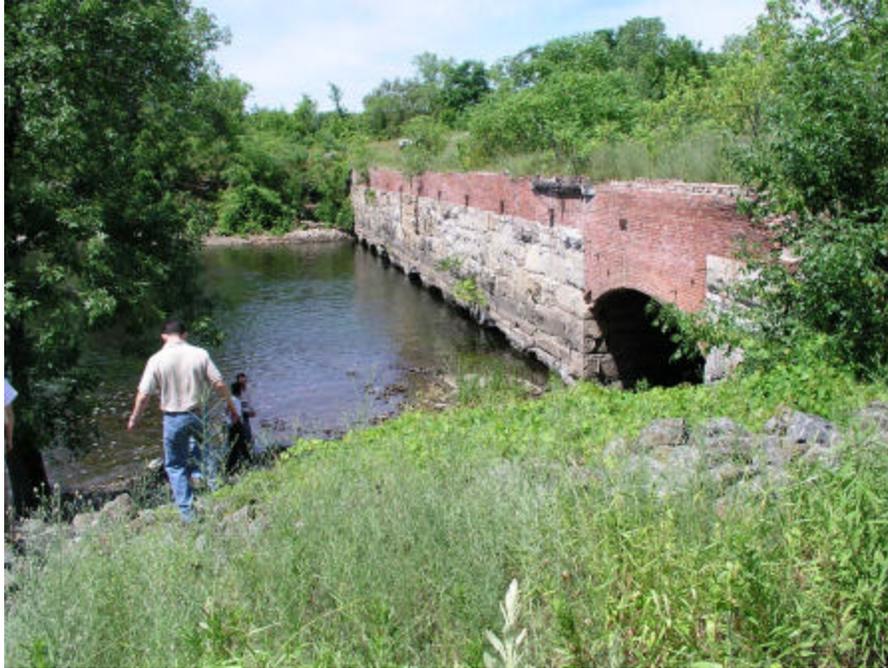
View to west of former power generating canal outfall (07/10/03).

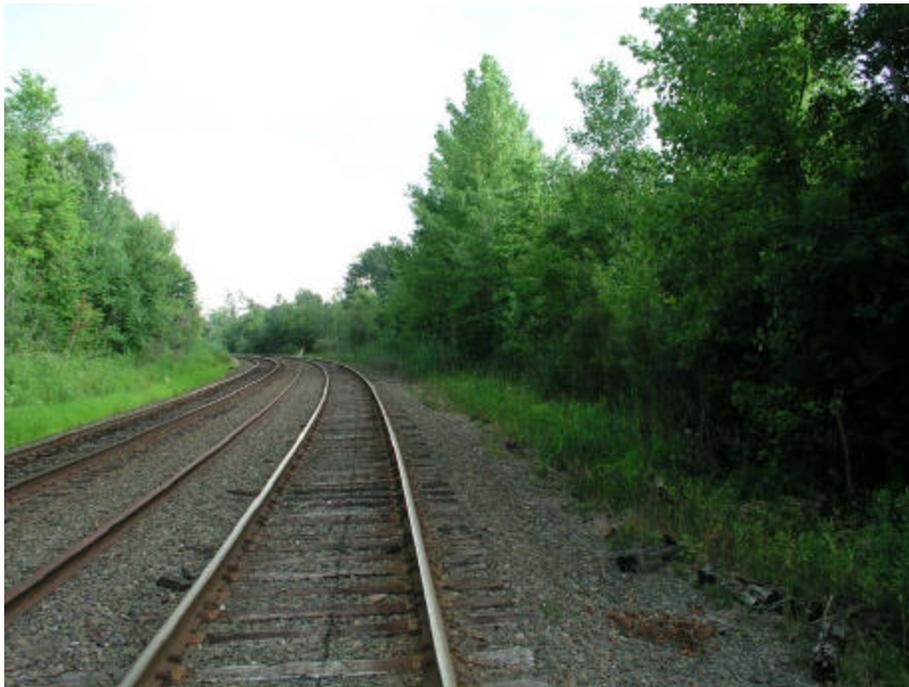
View to southeast of railroad tracks (07/24/03).

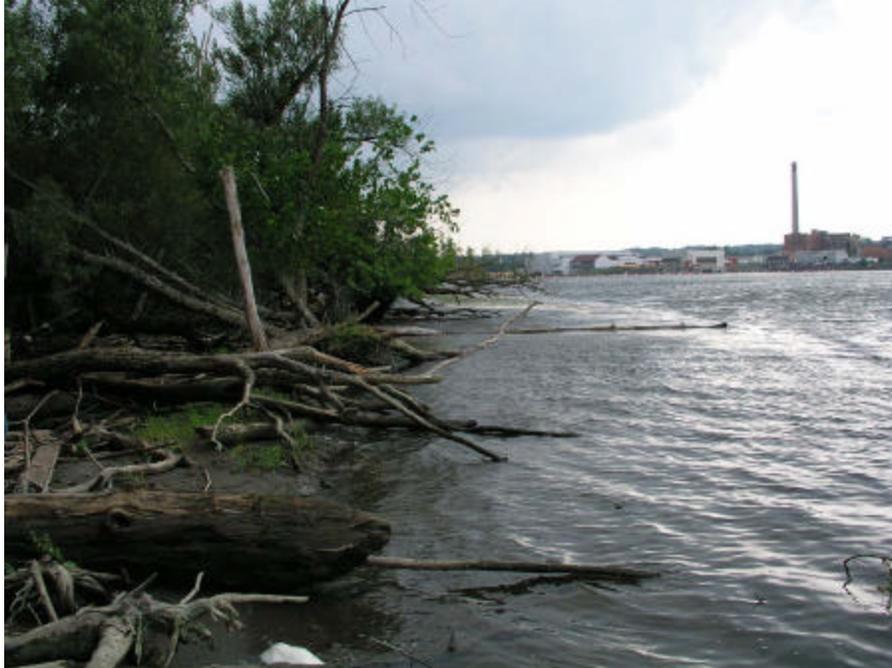
View to south of shoreline (07/24/03).

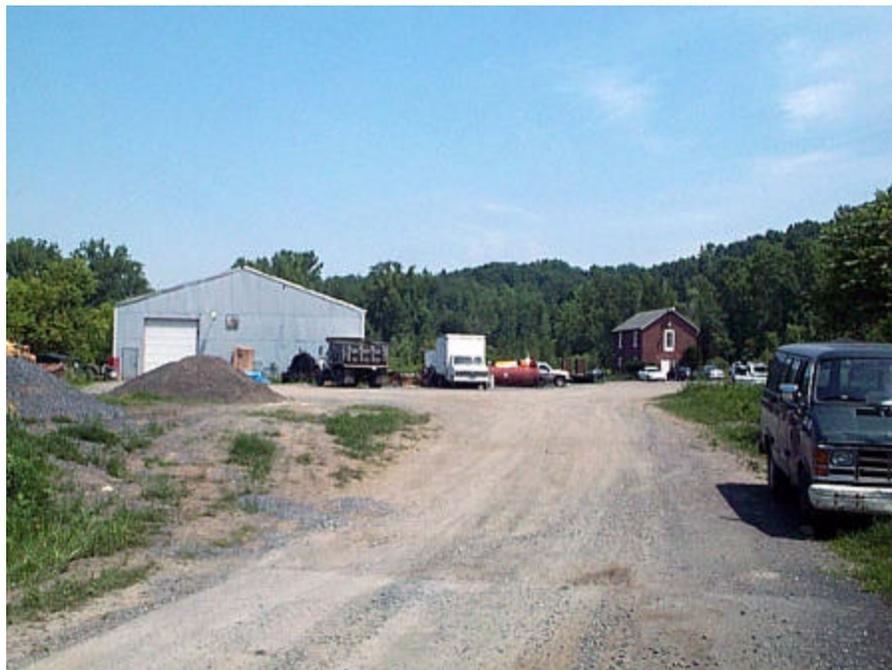
View to north of Shop building (left) and Office building (right) (07/24/03).

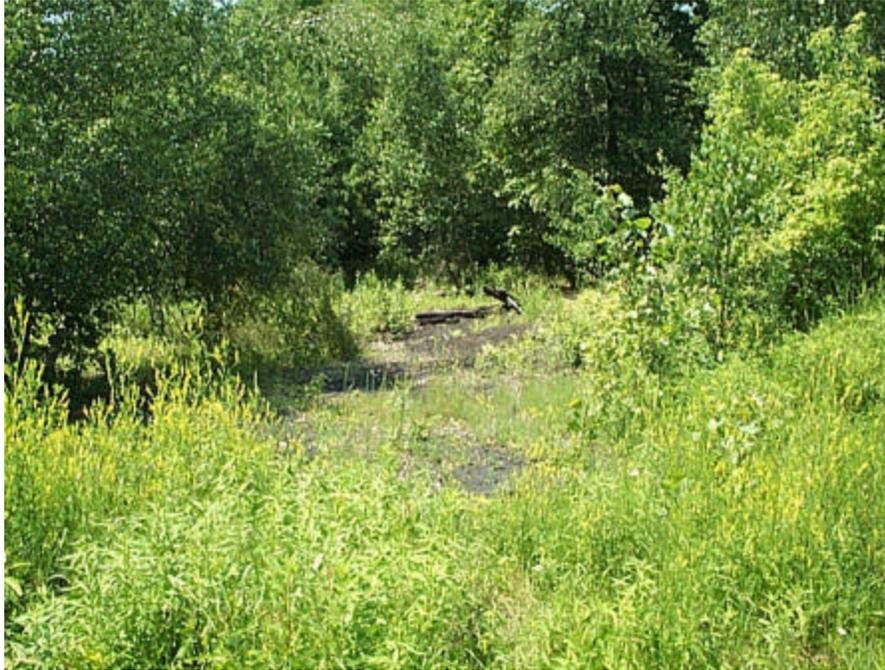
View to northwest of former coal storage area (07/24/03).
